1100 Years of Goslar: A World Heritage in Decay

Report about an institutional failure
(Short version)

Written by architect Henning Frase

World Heritage Watch

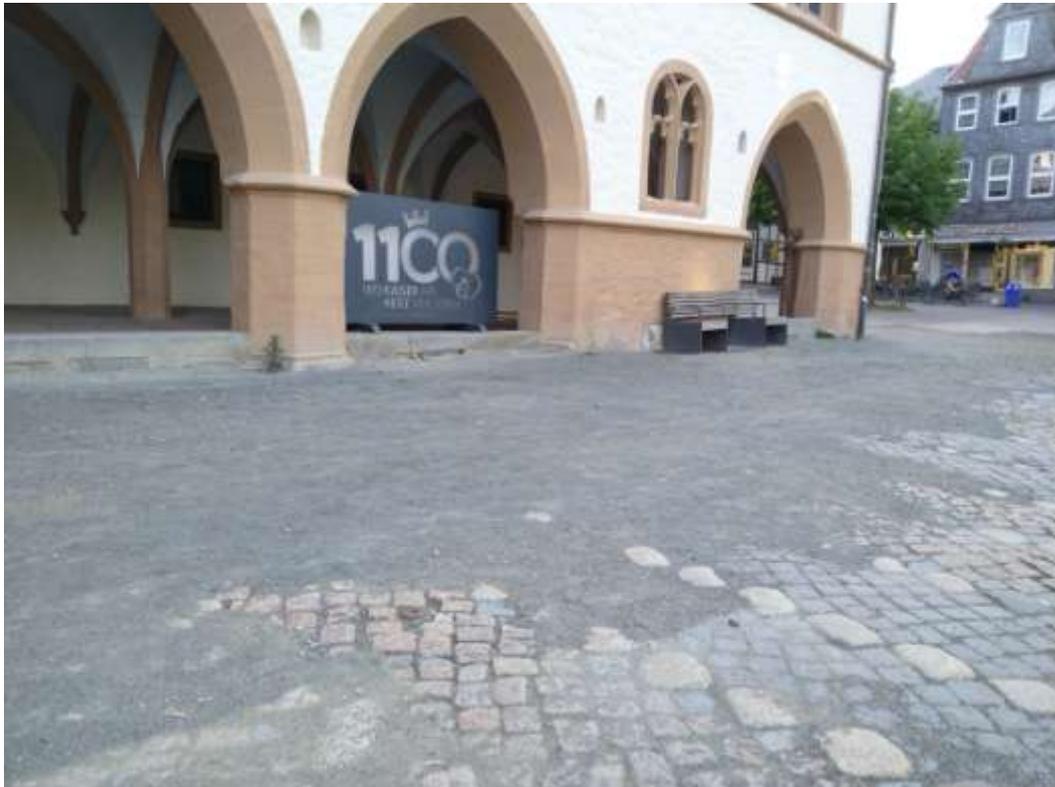
Market Square

View in May 2022 with advertisement for the 1.100-year city jubilee.

The most important facade view of the city of Goslar - painted, drawn and photographed countless times for centuries - still presents itself unfinished after twelve years and more than €12 million in construction costs. For 12 years, a large area of the radiant natural stone paving which has been in front of the town hall since approx. 1840, has been missing in front of the town hall.

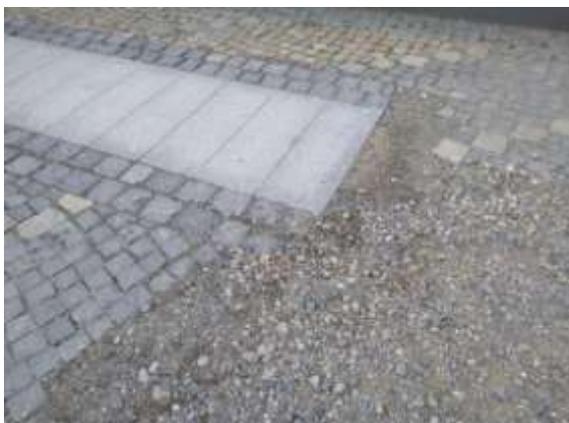
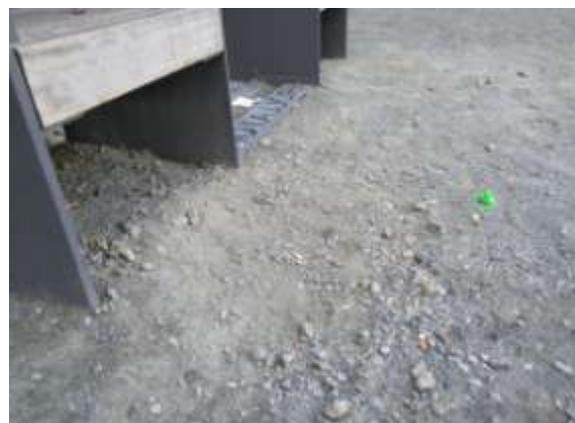
In 2021 it was considered to frame the radiant pavement of the market square with inappropriate grey granite slabs. This idea met with wide public resistance and was not implemented. Presently, the area is covered only by grey gravel.

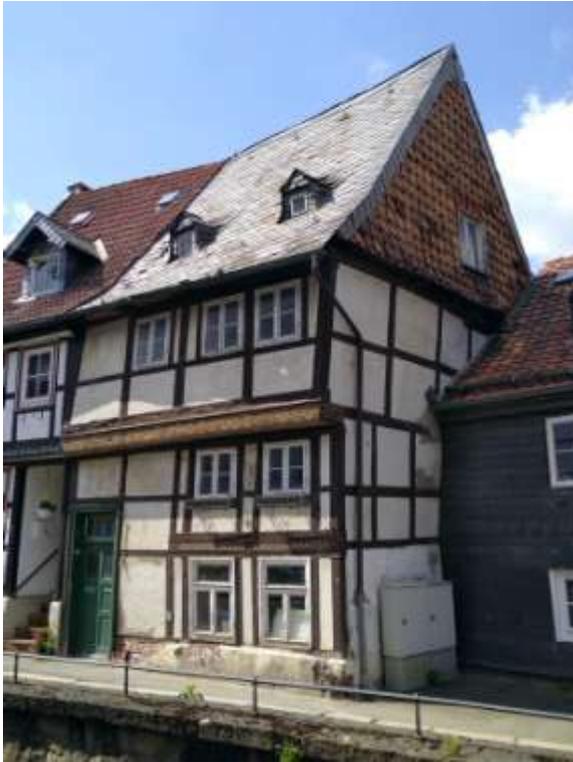
View of the street facade.

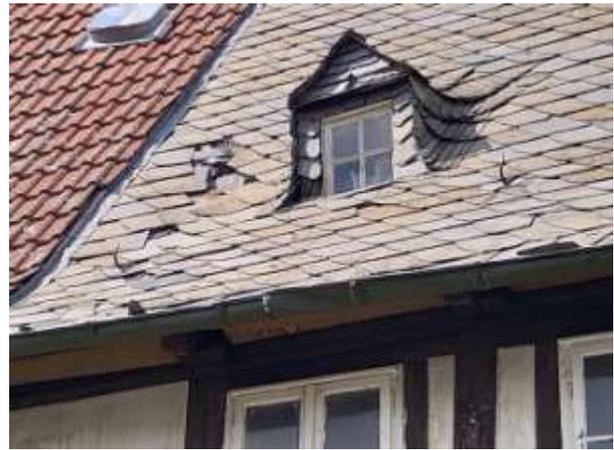
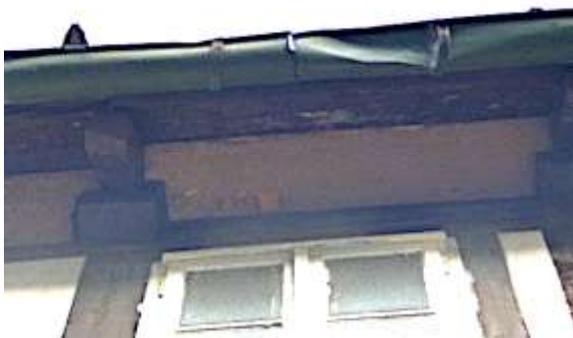
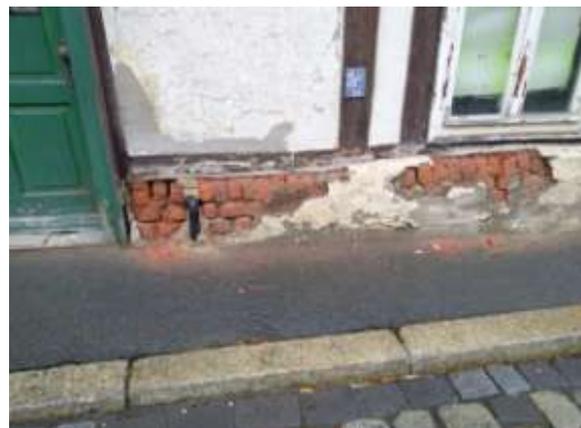
Due to the roof, which has been leaking for a long time, rainwater enters the building and destroys the building structure. Rainwater has been running through the broken gutter and down the building for years, destroying the framework and masonry.

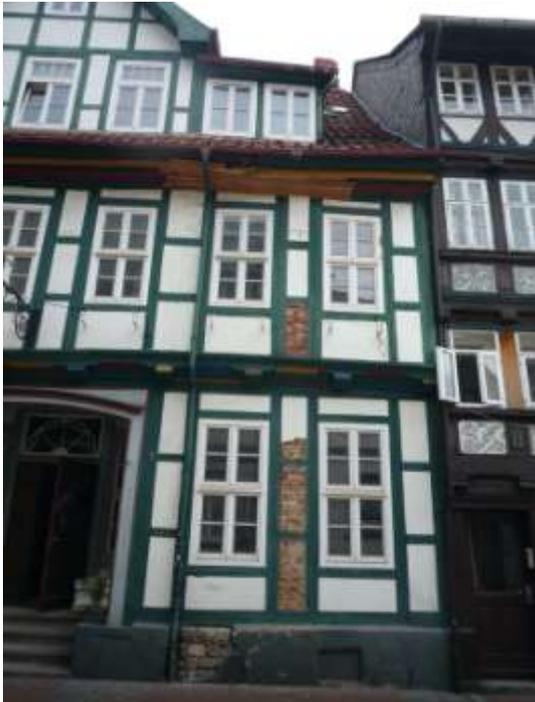
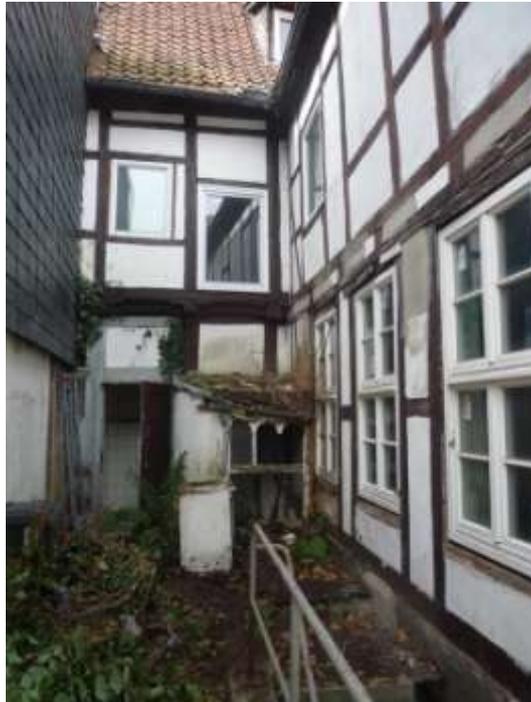
View of the inner courtyard in 2016. Defective gutters and lack of supervision led to rot in large wall areas of the truss. The inner courtyard was overgrown with trees and shrubs.

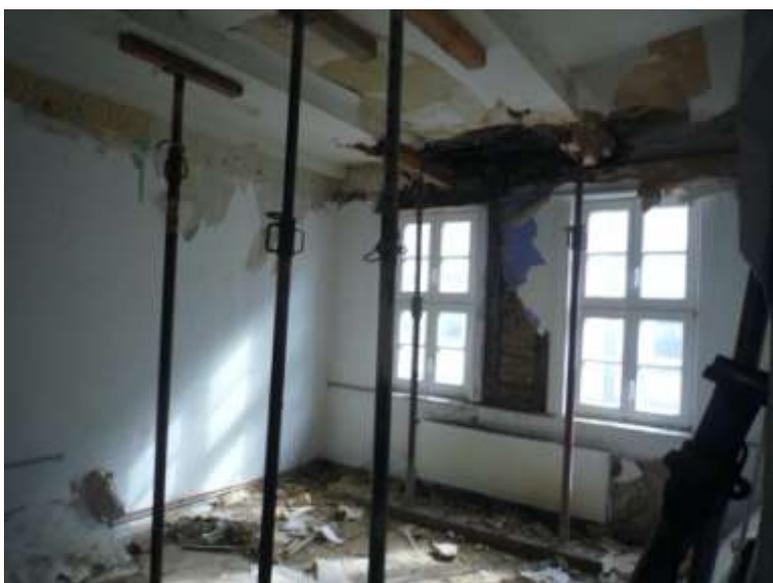
Interior view of the 1st floor with emergency braces as protection against collapse of the floor ceiling to the street side.

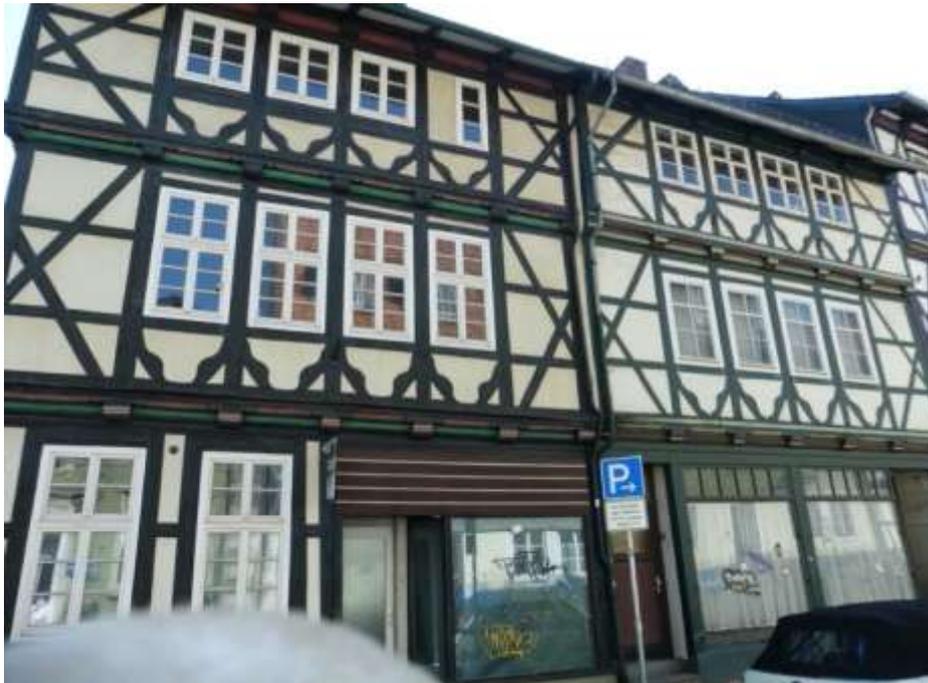
The baroque building stood empty for 10 years and was almost completely demolished inside. The back was covered with a tarpaulin for several years.

The buildings are an absolutely indispensable part of the development on Breite Straße and were in danger of disappearing from the cityscape due to years of decay. Attention was already drawn to this in the 2016 World Heritage Monitoring Black Book. Since 2019, the buildings have been restored.

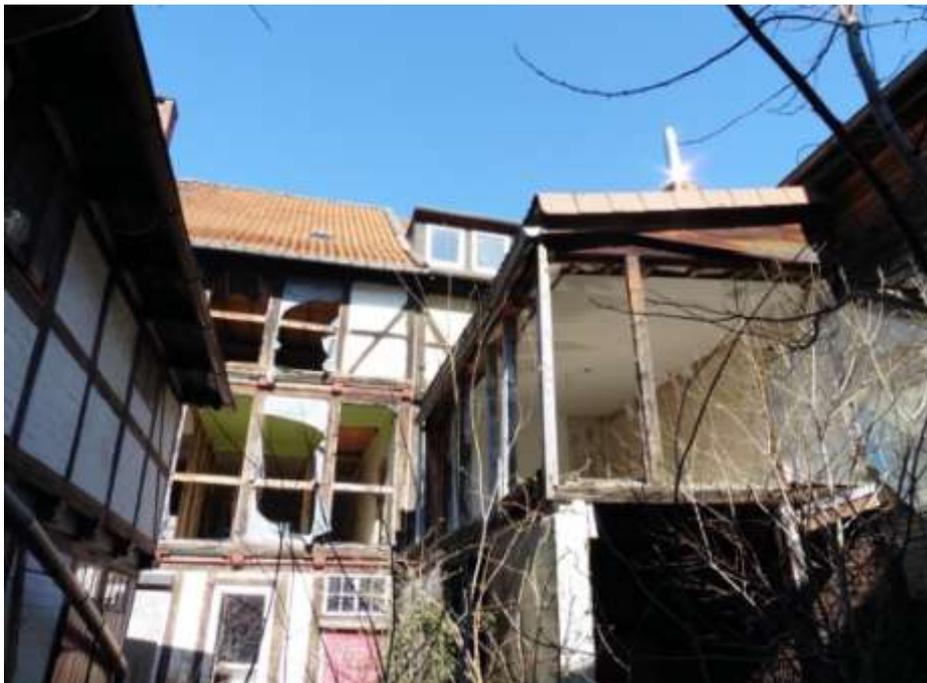
View of the backside of the building until 2019.

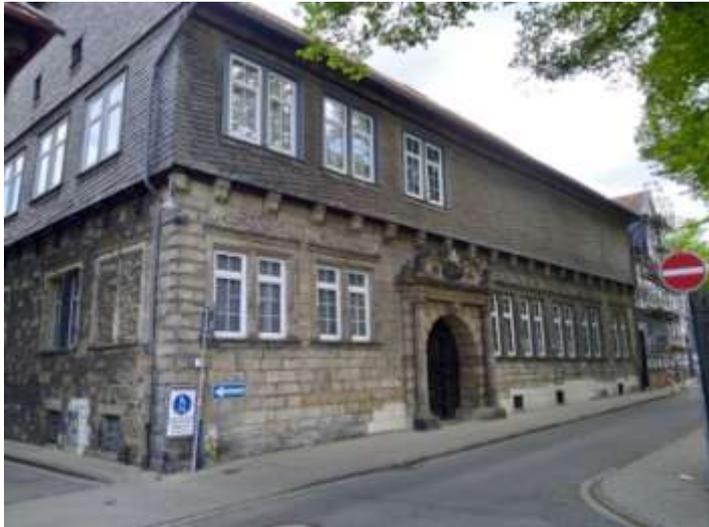
Core building 1501 with later extensions. Seat of the Masonic Lodge Hercynia zum flammenden Stern i. O. Goslar. The entrance to the building is one of the most beautiful entrances in the city of Goslar. The sandstone work around the entrance is of outstanding quality. The repair work on the sandstone masonry to the sides of it is of such poor visual quality that it significantly disturbs the overall appearance of the facade.

Street view.

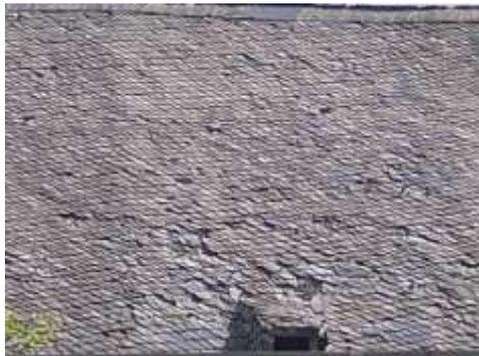
View of the front side of the building with clearly visible decay of the slate roof.

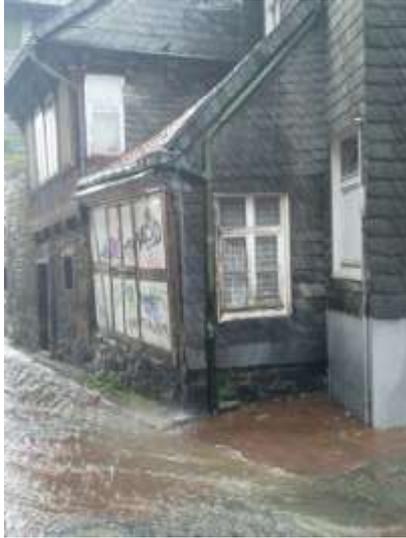
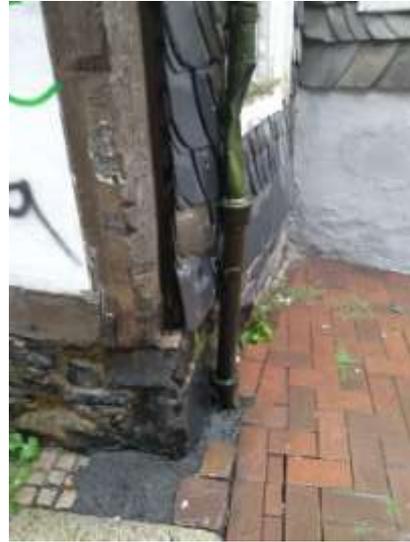
Rear side of the building located on Bäckerstraße Marktstraße 26. The building is decaying with the knowledge of the Lower (municipal) Monument Protection Authority of the city of Goslar for years. Every time it rains, water runs into the half-timbered structure.

Downpipe at the building broken for years.

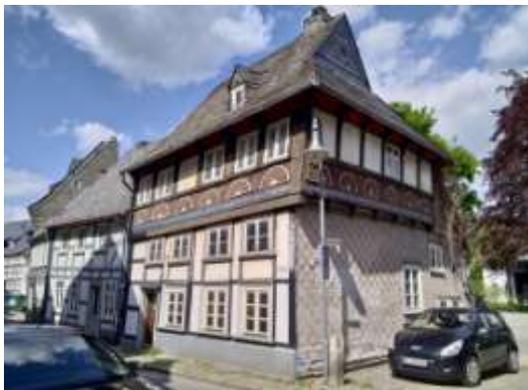
Built in 1608. The building has been vacant for a few years and is increasingly decaying.

Street view.

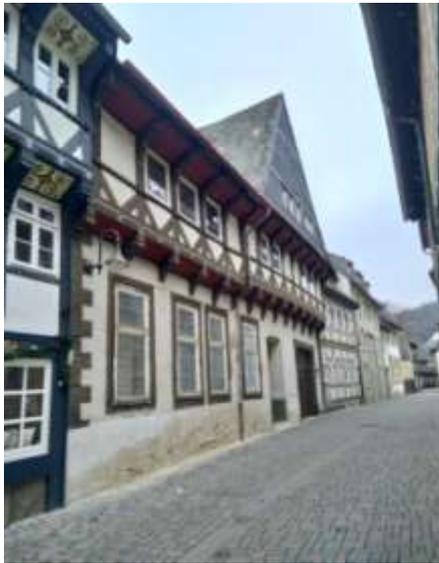
Built around 1510, the building still has a very beautiful baroque staircase inside and has been in a conspicuously poor condition for decades. The facades facing Worthstraße and at the rear of the building appear disfigured by the single-pane windows. The half-timbering has been recognizably in need of repair towards Worthstraße for many years.

View from the Worthstraße.

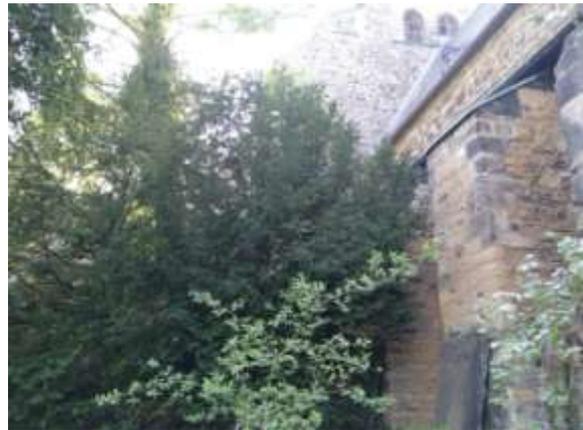
Plants growing too close to the building. Risk of humidity and loss of visual integrity.

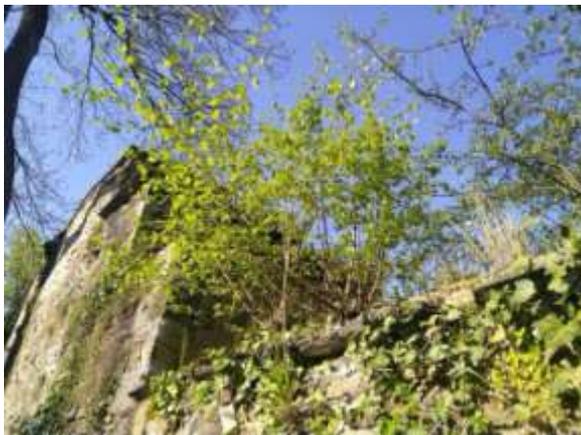
Trees growing on the city wall. The growing roots destroy the top of the wall.

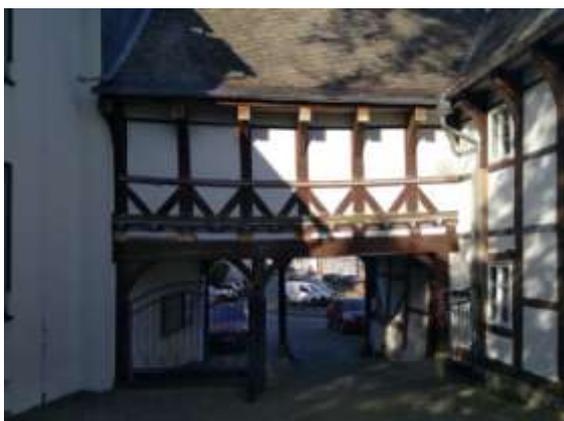
Backside passage to the church. Probably due to a roof strut broken for a long time, Water has run down the facade and has Destroyed the truss.

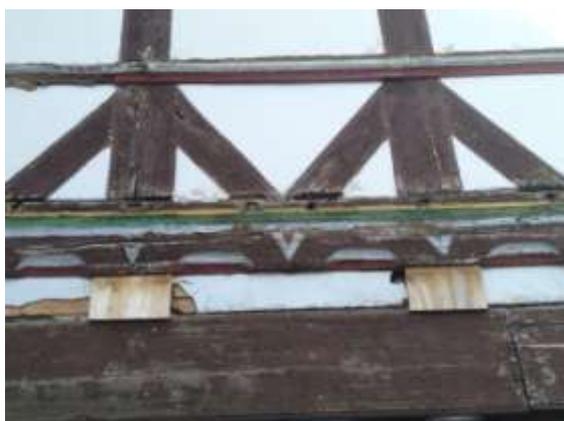
Destroyed truss at the transition from the swellwood to the stems and struts.

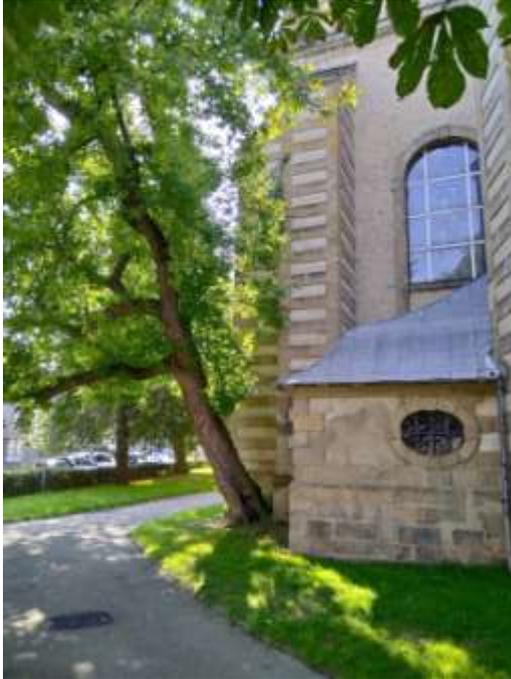
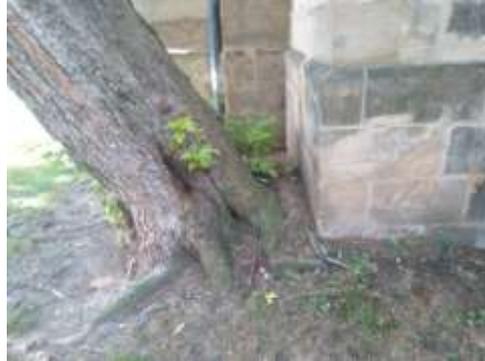
Tree growth directly on the choir of St. Stephani Church. The roots of the tree grow directly next to the foundation walls and can cause severe damage when they grow into the foundation walls. If the tree snaps off due to its slanted position, there is a risk that parts of the building will be broken out of the choir of the church.

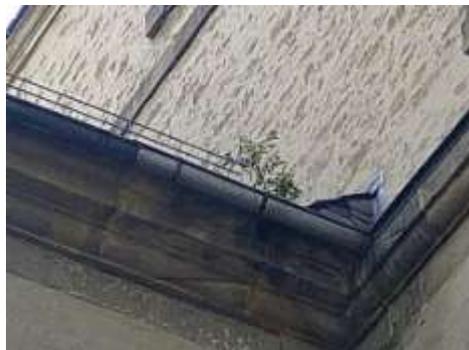
Tree growing in the gutter, 2021.

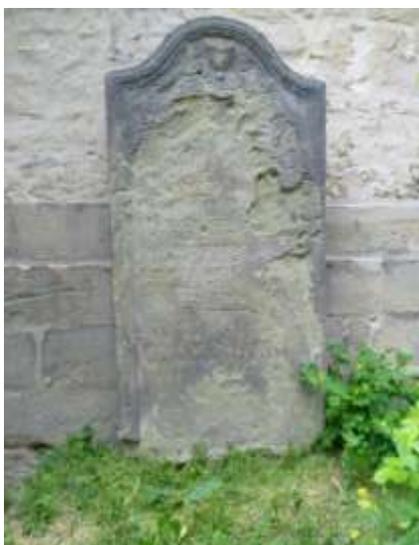
The gravestone has been decaying for years with knowledge of the Lower Monument Protection Authority. For its conservation it should be moved to another location, or separated from its underground, and have a roofing.

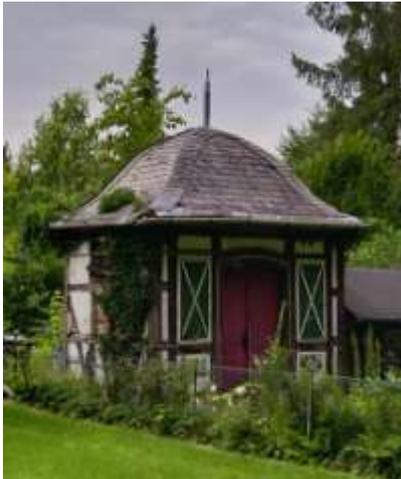
The pavilion is located in the gardens of the ramparts behind the St. Annenhaus. The slate roof and the gutter have been damaged for about 10 years. Rainwater has been running into the building for many years. Approximately 45% of the roof and walls have already been damaged to such an extent that the original building fabric has been irretrievably lost. Rescue actions up to the offer to move the pavilion to save it from demolition have been unsuccessful so far. The deletion from the list of monuments and the subsequent demolition seem to follow in the near future.

The pavillon with its entrance.

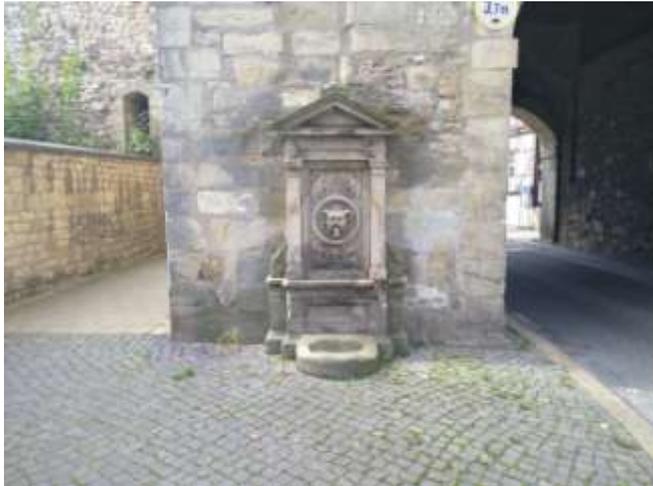
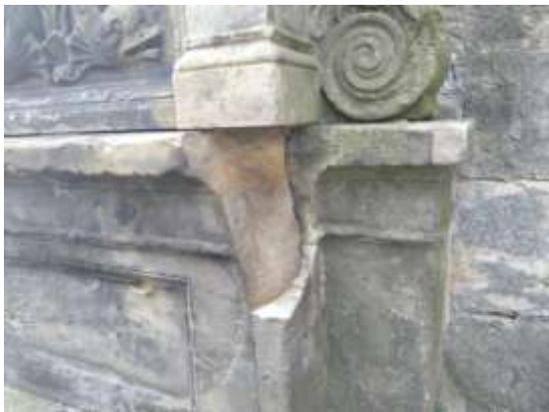
Part of the fountain broken out since 2021.

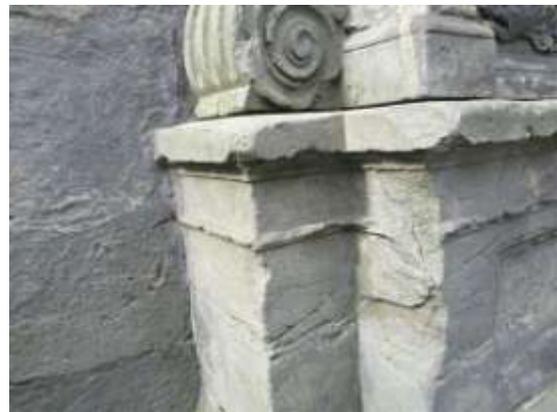
Left side of the fountain with parts of the sandstone having flaked.

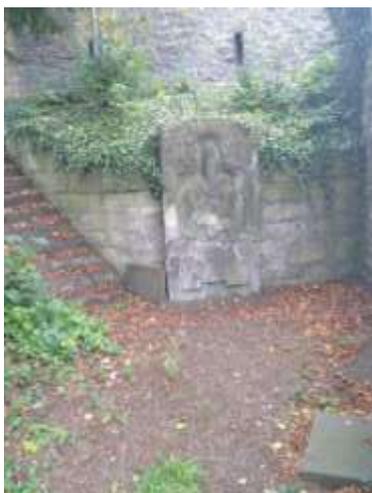
Gravestone monument in the garden Of the Werderhof. Due to its wrong positioning, the gravestone exhibits beginning damages of the sandstone.

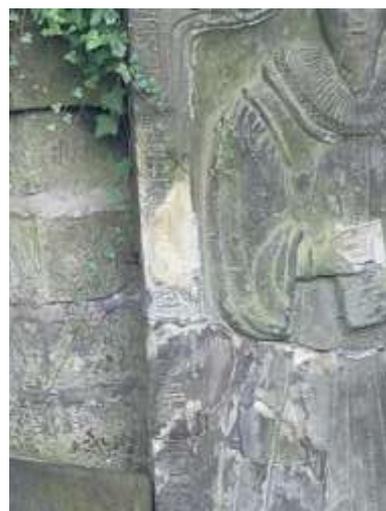
Visible points of fracture and damages in the sandstone.

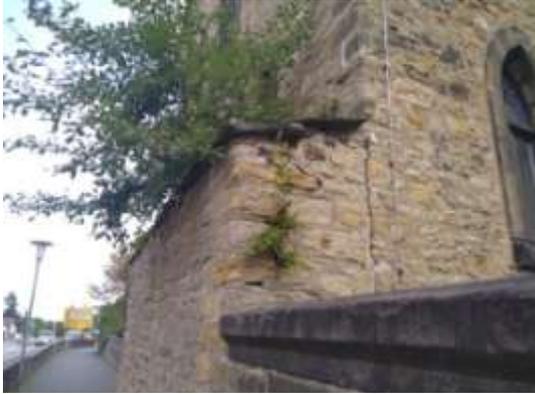
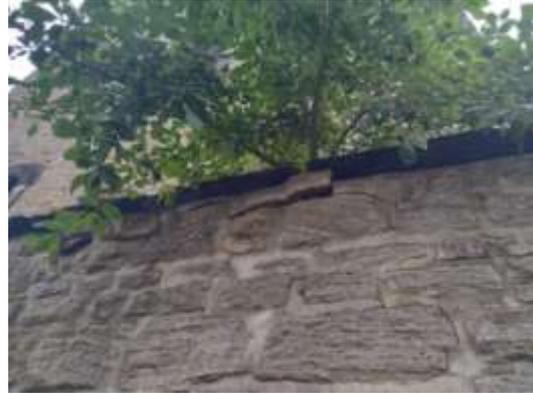
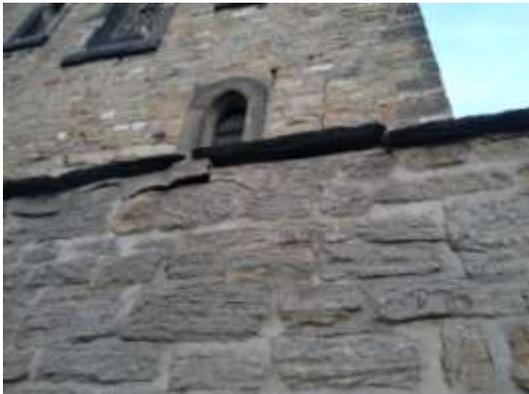
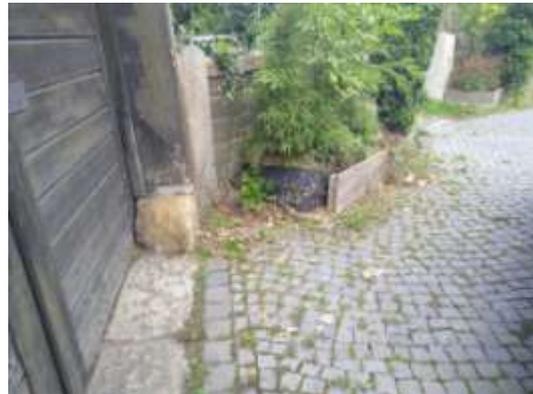
On the city wall next to the Werderhof, for years a willow could grow out of the wall up to 3 meters high. It was removed only in 2022. What remained was the damage to the masonry, which was not repaired.

Damage to the masonry.

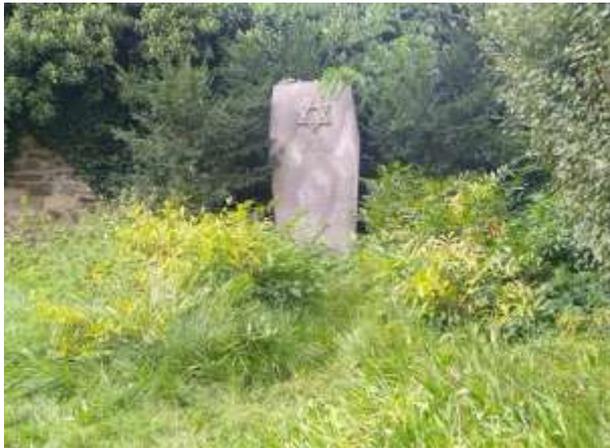
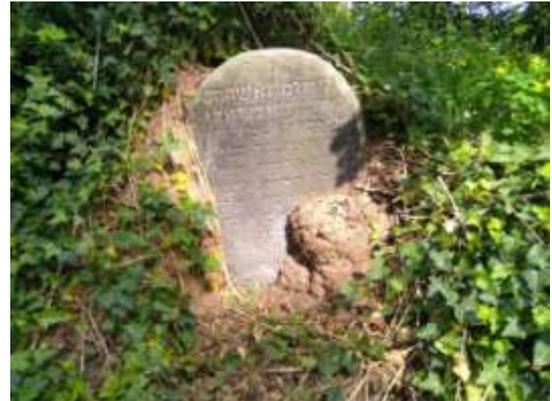
The photos were taken in 2021 und 2022. The cemetery shows clear signs of neglect. The natural stone wall facing Glockengießerstraße has been heavily overgrown with ivy for years. Likewise, many gravesites along the wall, and the rest of the grounds have been overgrown with ivy. Next to the entrance, an ash tree, which has already been cut back several times, grows directly on the wall. The ivy growth has probably already caused significant damage to the wall. Despite the recent cutting back of ivy, the entire cemetery is in need of a basic horticultural overhaul.

Centraler memorial stone in a clearly unkept environment.

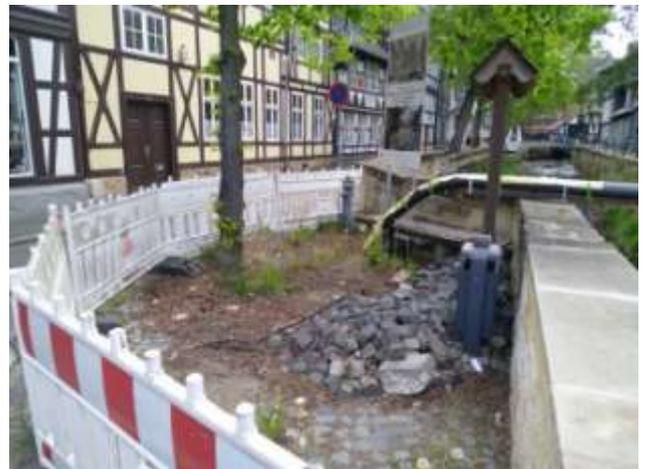
Repair works at the bridge over the Abzucht have never been completed since the flood event of 2017.

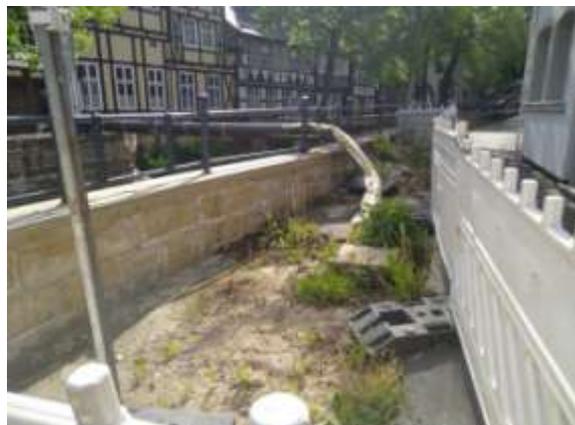
The works were started only in 2021 and then aborted. The construction site is fenced off and growing over with weeds.

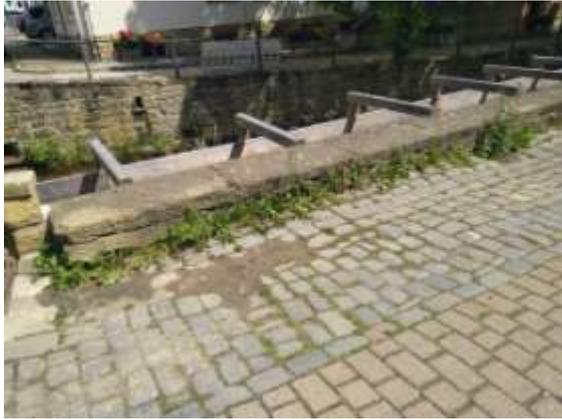
Condition of the pavement at the “Gerenne“, another wooden run-off system, in 2021.

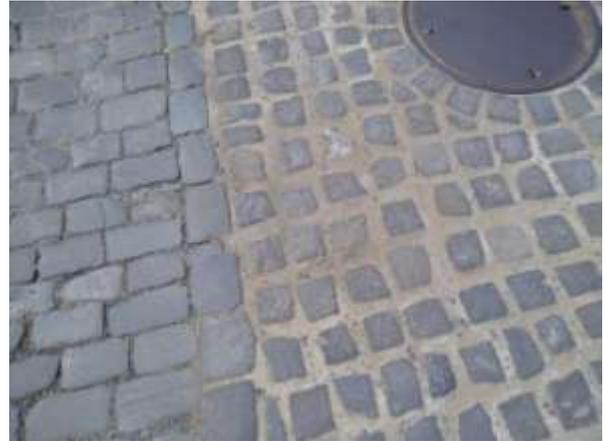
Newly-laid pavement of natural stones in 2021 on the bridge with too wide spacing between the joints.

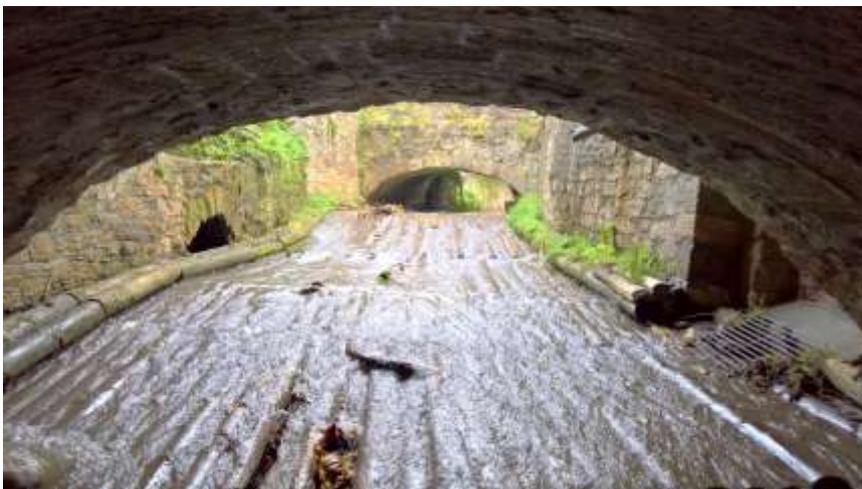
The Untere Wasserloch is part of the medieval fortifications and the outlet of the Abzucht, the town moat flowing through the town of Goslar. In 2017, during a prolonged heavy rainfall, the stream caused a flood in the city leading to about 10 million EUR of damage to the historic fabric and infrastructure.

No less than 6 watercourses cross or flow into each other here (GRIEP 1986). In the flow-through area of the structure there is, for example, a mill race whose state of preservation must be classified as in urgent need of rehabilitation. In the event of a recurrence of flooding, there is a risk that it will collapse. In the event of a partial blockage in the water drainage under the building due to flotsam carried along, the course of the stream would dam up again - as it did in 2017 - in the lower town and would probably lead to very extensive damage again. A complete blockage would completely submerge the lower town within a very short time.

The Unteres Wasserloch – view towards the east.

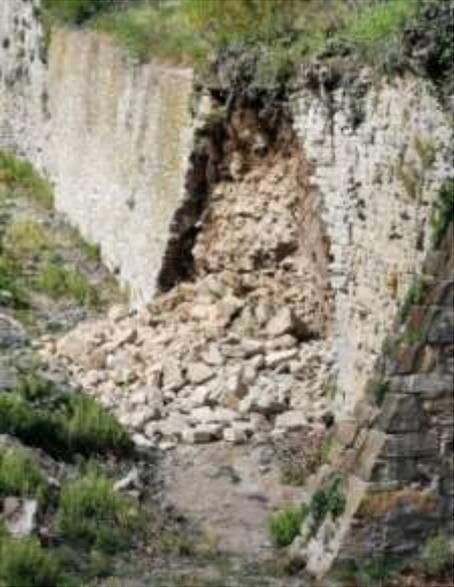
In 2020, a section of the field wall next to the railroad tracks collapsed. Its dilapidated condition was certainly noticeable over a longer period of time and was not repaired. The field wall is part of the medieval fortification of the city. The renovation section extends over approx. 700 m.

Partial collapse of the field wall in April 2020.

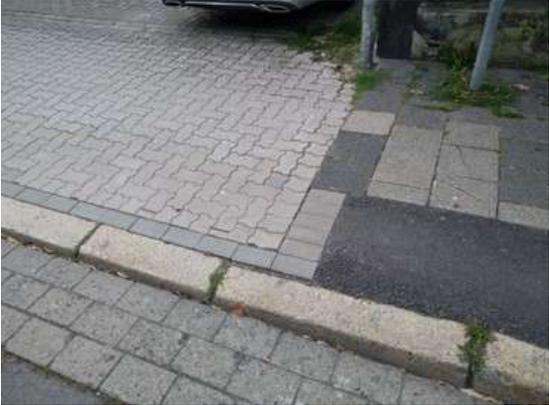
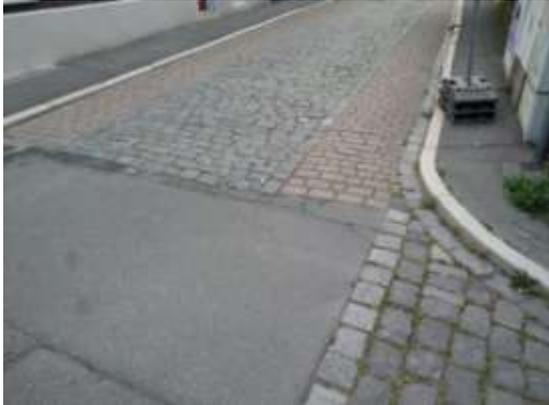
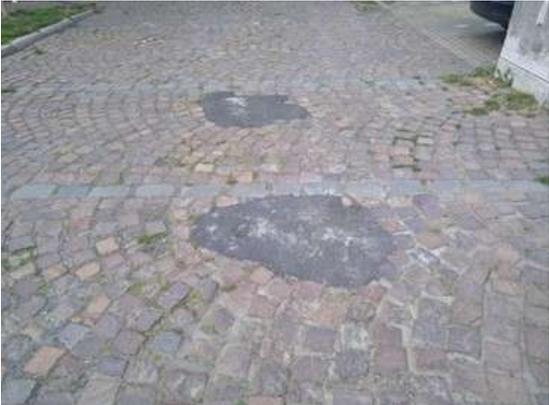
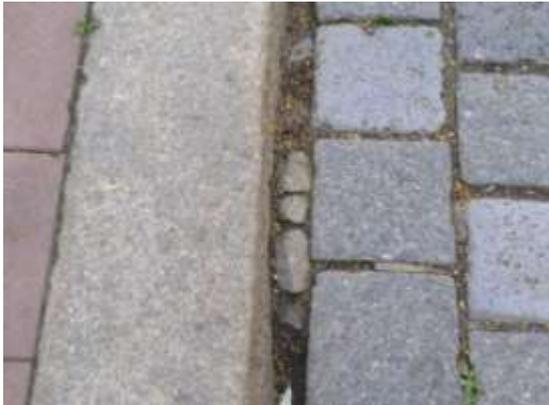
Boardwalk of the Glockengießerstraße at the new Kulturmarktplatz, and other examples.

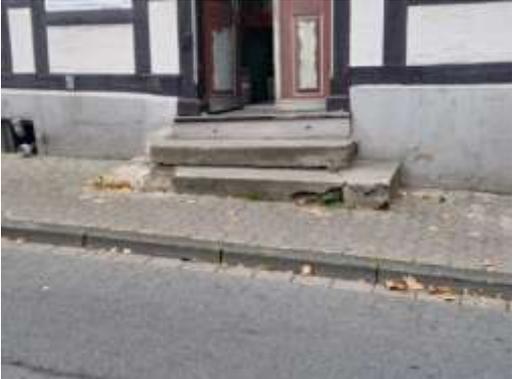
Entrance to Charley-Jakob-Str.1, next to a municipality building. The staircase, directly in front of the office of the Lower (municipal) Monument Protection Authority of Goslar, has been decaying for many years.

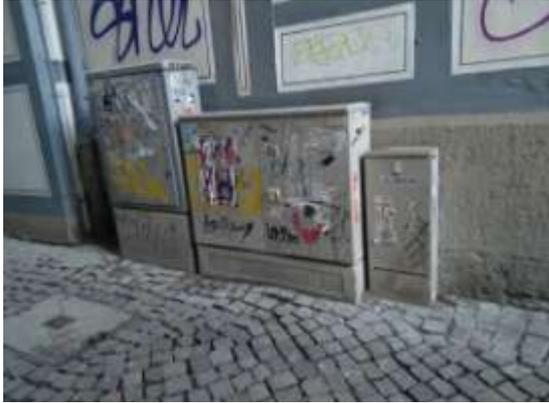
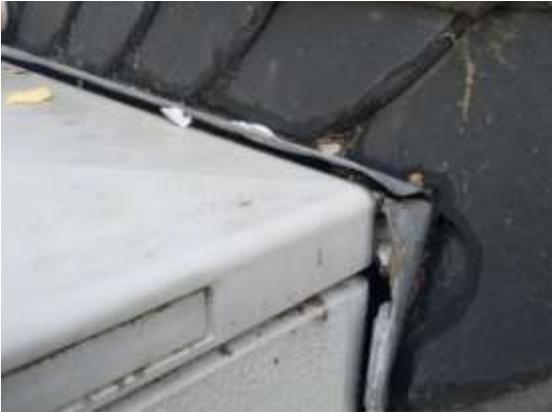
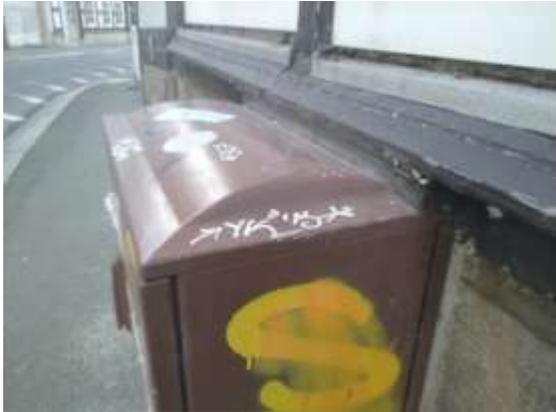
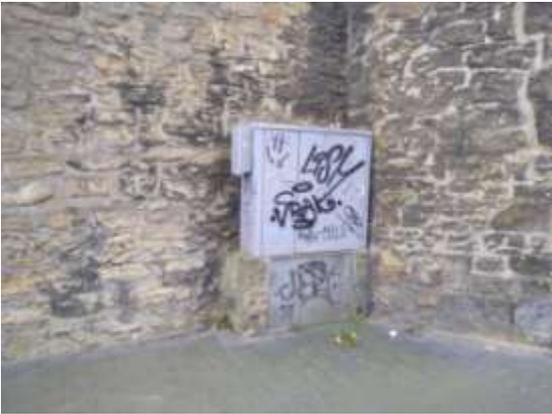
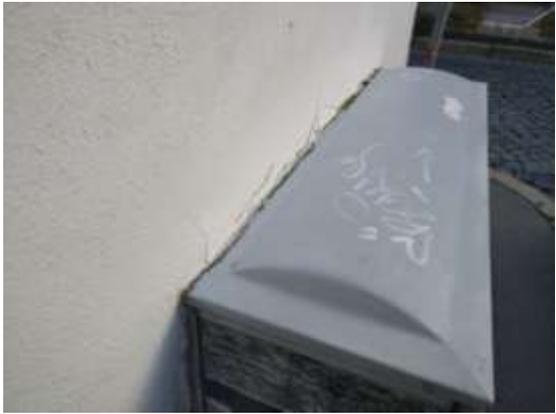
Throughout the old town there are distribution boxes placed in front of buildings. Many of them are regularly pasted or sprayed with paint. More serious, however, is the small distance from the building's exterior walls, which can create a permanently damp gap and thus increase the risk of building damage. Useful design solutions to prevent water ingress are difficult to identify.

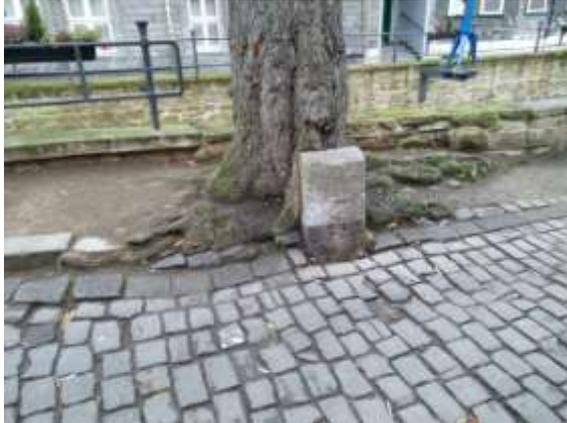
For many years, the roots of the linden tree have grown into the pavement and around the curb. The tree is located on the Abzucht and right next to the City Museum.

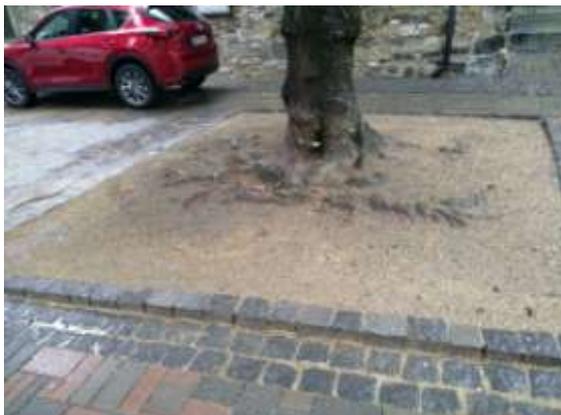
Exposed roots at the Market church.

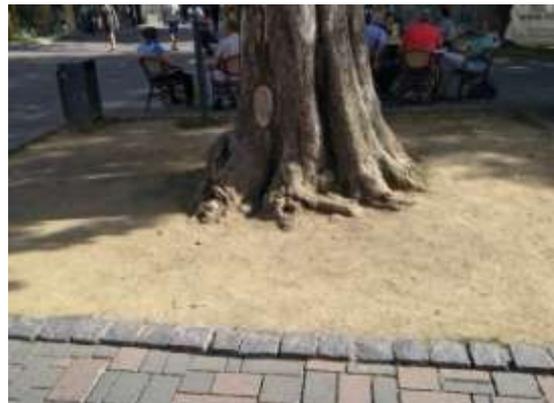
Jakobi church: roots of a chestnut tree damaged since many years.

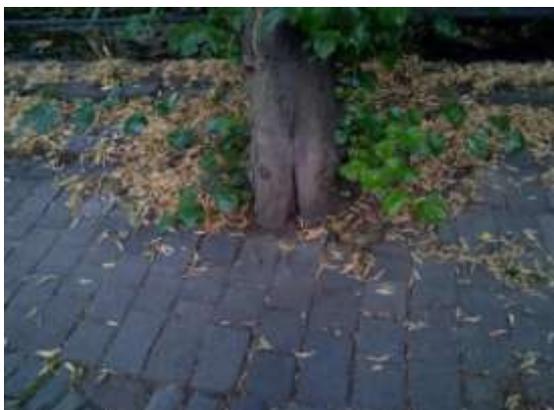
At the Abzucht, with adjacent concrete pavement.
